## How Effective Are Bathtub Grab Bars for Stopping a Fall When You Lose Your Balance?

## Research Highlight

**Research Report:** How Effective Are Bath Grab Bars for Stopping a Fall When You Lose Your Balance?

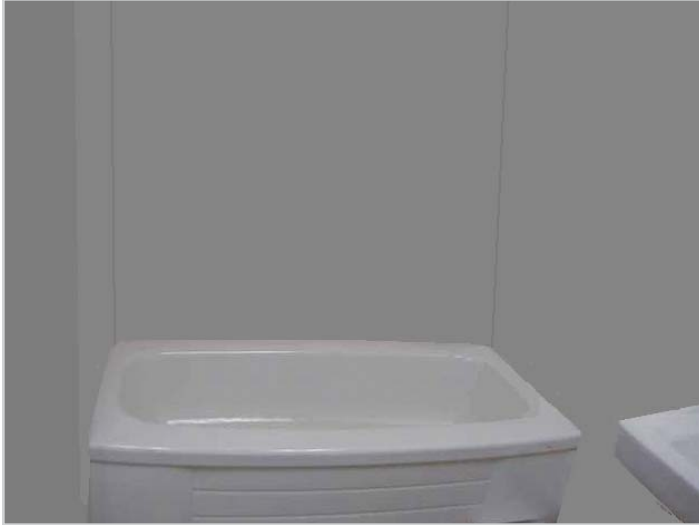
**Figure 1** Grab bar configuration: No bars

- (1) No bars, where no grab bars were provided. *See figure 1;*
- (2) CSA (Canadian Standards Association) configuration, consisting of a vertical bar on the side wall and a horizontal bar on the back wall. *See figure 2;*
- (3) OBC (Ontario Building Code) configuration, consisting of a right angled bar on the back wall. *See figure 3;* and
- (4) OCC (Ottawa-Carleton Common) configuration, consisting of a vertical bar on the side wall and an angled bar on the back wall. *See figure 4.*

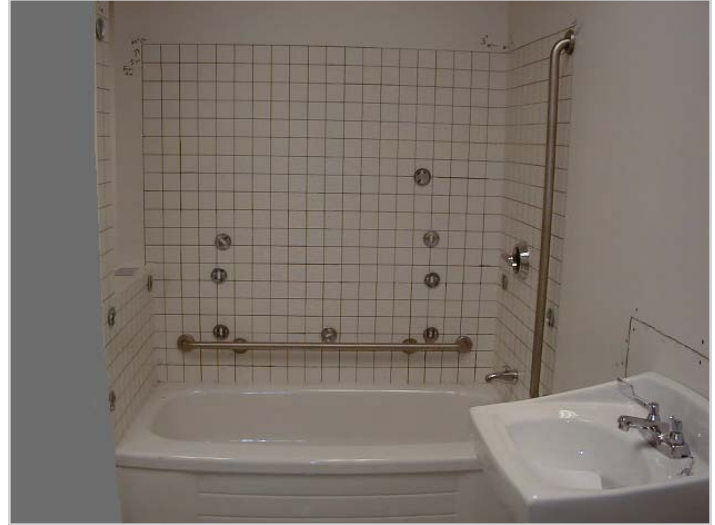
**Figure 2** Grab bar configuration: Canadian Standards Association (CSA)

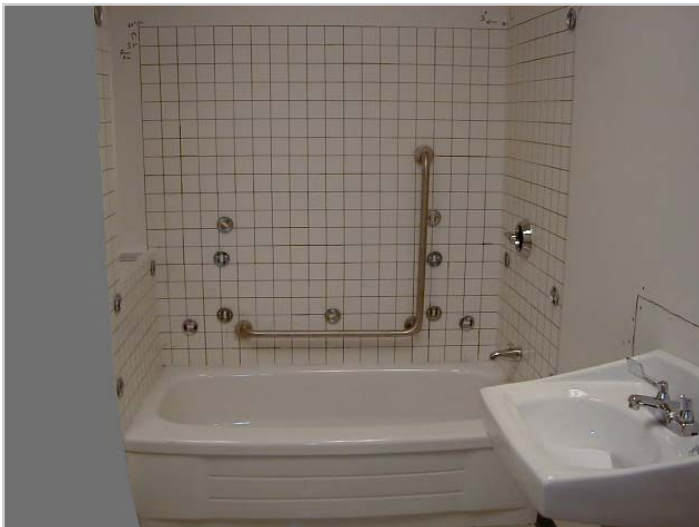
**Figure 3** Grab bar configuration: Ontario Building Code (OBC)

- The grab bar configuration requirements in the 1997 version of the Ontario Building Code (OBC) should be revised to include a bar on the side wall. This will facilitate bathtub entry/exit and ensure safety in all phases of bathing.

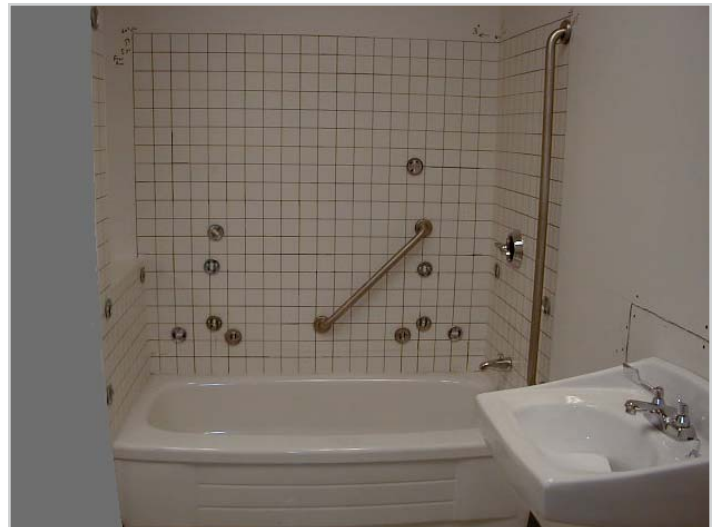
**Figure 4** Grab bar configuration: Ottawa-Carleton Common (OCC)

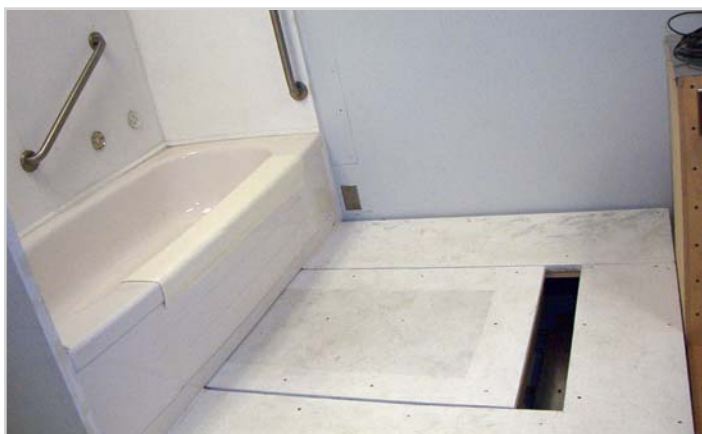
**Figure 5** Platform used to induce balance perturbation

Participants were asked to assess the bathtub grab bar configurations. A platform (*see* figure 5) that moved 20 cm forward and backward at an adjustable speed reaching up to 24 cm/sec was used to induce balance perturbation among both younger and older adults. The mock bathroom (*see* figure 6) consisted of a bathtub (1.52 x 0.76 x 0.41 m) surrounded by three walls at right angles, and designed to accommodate the grab bar configurations and built over the structural frame of the platform at a perpendicular angle. When activated, the platform moved back and forth under the bathtub. The bathtub was lightweight and made of acrylic. Its rims were padded with light foam. All grab bars had non-slip surfaces. Participants wore protective hip garments and were secured in a harness to prevent injury in the unlikely event of a fall.

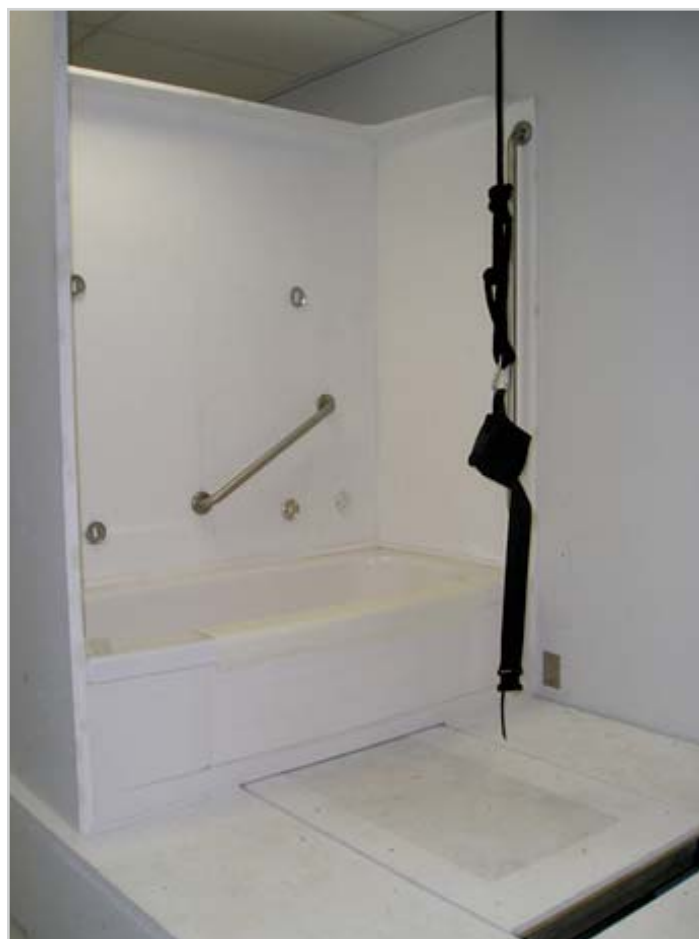
**Figure 6** Mock bathroom and safety harness.

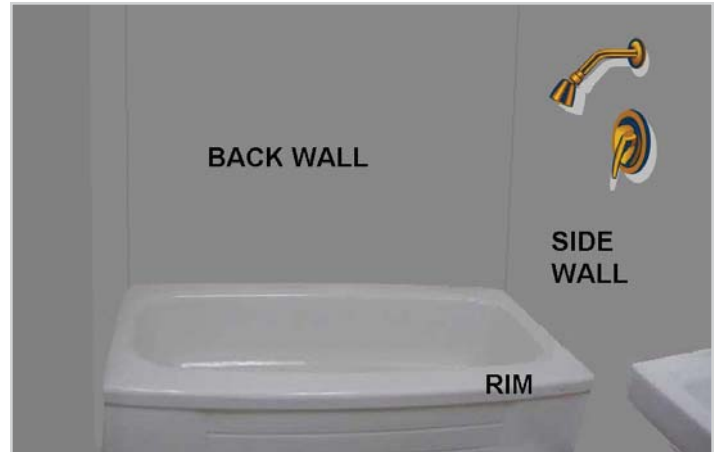
Figure 7 Structure surrounding the bathtub

In the older adults, 80% (831/1,040) of the bathtub entry/exits with platform activation recorded resulted in a balance loss. In 79.3% (659/831) of these, participants required contact with the surrounding structure to regain their balance (see Figure 7). In the absence of grab bars, older adults favoured, in order, the side wall, the bathtub rim and the back wall.
